Project Name	Stellos Stadium ASTM F1936-19 g-max Impact Evaluation		
Client Info	R.A.D. Sports 171 VFW Drive Rockland, MA 02370	Site Info	Stellos Stadium 7 Stadium Drive Nashua, NH 03062
Report Date	10/2/2024	Test Date	10/2/2024
Report Status	Final	Job No.	100045/10223s
Prepared by	Michael Rocheleau Field Operations Manager

Firefly Sports Testing was commissioned to perform on-site g-max impact testing per ASTM F1936-19. A complete test was performed in accordance with the ASTM F1936-19 Standard. The results have been summarized in the quick reference table below. Test results herein reflect the performance of the points tested, at the time of testing and at the temperature(s) reported. Complete results and background can be found in the subsequent sections of this report.

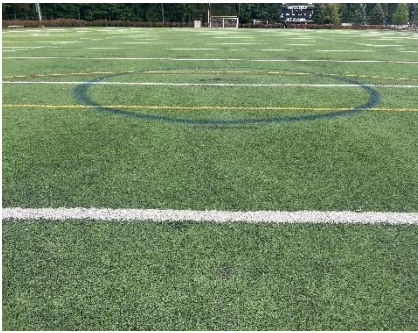
Location #1

Loc #	Location Description	Drop 1 g-max (g's)	Drop 2 g-max (g's)	Drop 3 g-max (g's)	Average g-max (g's)	Infill Depth (mm)	Surface Temperature (°F)
1	Goal Line, End A, center of field	194	204	209	207	28	65
2	10 Yard Line, End A, 63 ft from center of field to Side C	143	159	163	161	34	65
3	25 Yard Line, End A, 40 ft from center of field to Side C	155	173	174	174	29	65
4	Center of the field	210	228	229	229	25	65
5	25 Yard Line, End B, 63 ft from center of field to Side D	140	157	160	159	34	65
6	12 Yard Line, End B, center of field	192	213	215	214	25	65
7	35 Yard Line, Side D, 6 ft outside of the in-bounds line	144	157	158	158	34	65
8	37 Yard Line, End B, 40 ft from center of field to Side C	143	158	157	158	36	65
9	6 ft from Goal Line to the back of the End Zone, End A, center of field	155	176	180	178	31	65
10	6 ft from the back of the End Zone to the Goal Line, End B, center of field	181	201	207	204	30	65

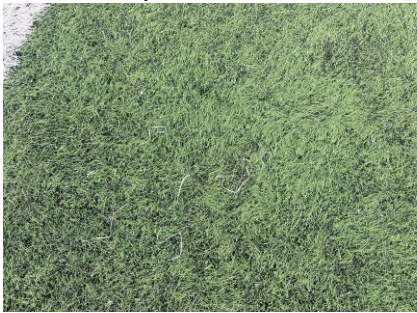
Item 1

Item No.	X	Y	Length, X (ft)	Width, Y (ft)	Deviation Type	Comments
1	I.3	5			FL- Loose Fibers	White fibers loose around entire field
2	E	3.1	0.5	0.5	SF – Seam failure	
3	F	3.1	1	0.5	SF – Seam failure	
4	G	3.1	2	0.5	SF – Seam failure	
5	H.1	3.1	2	0.5	SF – Seam failure	
6	G.6	3.1	2	0.5	SF – Seam failure	
7	H.6	3.1	2	0.5	SF – Seam failure	
8	H.6	3.2	1	0.5	SF – Seam failure	
9	I	3.2	1	0.5	SF – Seam failure	
10	J	3.2	1	0.5	SF – Seam failure	
11	J.2	3.2	1	0.5	SF – Seam failure	
12	L	4.5	2	0.5	FW - Worn Fibers (High wear)	Yellow fibers across entire field degrading faster than green and white
13	J.6	5	5	5	FW - Worn Fibers (High wear)	
14	I	6.7	2	0.5	SF – Seam failure	
15	H	6.7	0.5	0.5	SF – Seam failure	
16	G.1	6.7	0.5	0.5	SF – Seam failure	
17	F.7	6.7	0.5	0.5	SF – Seam failure	
18	G	5	3	0.5	FW - Worn Fibers (High wear)	
19	F	6.7	0.5	0.5	SF – Seam failure	
20	E	6.7	1	1	SF – Seam failure	
21	D.2	6.7	2	2	SF – Seam failure

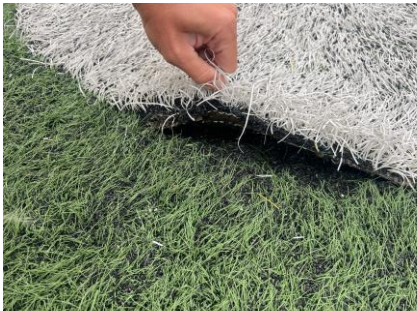
Item 22

22	D	6.7	1	0.5	SF – Seam failure	
23	C.4	5	1	1	SG – Gap in seam	
24	C.4	5	5	5	FW - Worn Fibers (High wear)	
25	C.4	5	5	5	IL– Lack of (Low) Infill
