Project Name:	Stellos Stadium		
Client Info:	Town of Nashua	Site Info:	23 Stadium Dr Nashua, NH 03062
Report Date:	7/15/2024	Test Date:	7/12/2024
Report Status:	Complete	Job #:	188311
Prepared by:	Roger Clough		
Checked by:	James Leszuk

Summary

On-Site Testing GMAX Impact Evaluation

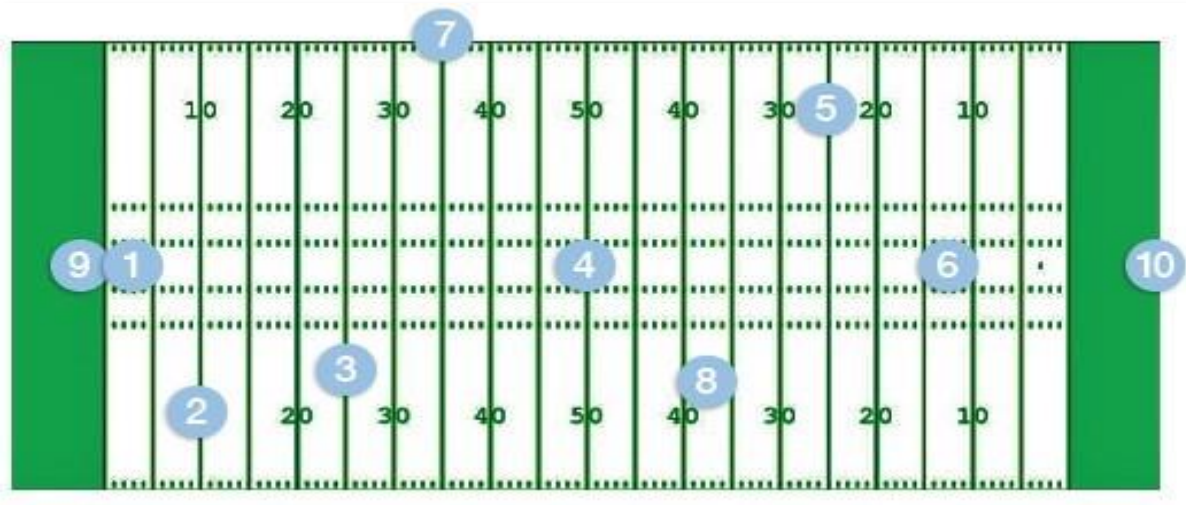
Location Map

The above table outlines your Gmax score for the second and third drop at each location on the field and an average Gmax score for both drops. The location numbers correspond to the above field map. It also includes an infill depth reading. Per ASTM standards your Gmax score should be under 200.
