Project Name	Stellos Stadium ASTM F1936-19 g-max Impact Evaluation		
Client Info	R.A.D. Sports 171 VFW Drive Rockland, MA 02370	Site Info	Stellos Stadium 7 Stadium Drive Nashua, NH 03062
Report Date	10/2/2024	Test Date	10/2/2024
Report Status	Final	Job No.	100045/10223s
Prepared by	Michael Rocheleau Field Operations Manager

Firefly Sports Testing was commissioned to perform on-site g-max impact testing per ASTM F1936-19. A complete test was performed in accordance with the ASTM F1936-19 Standard. The results have been summarized in the quick reference table below. Test results herein reflect the performance of the points tested, at the time of testing and at the temperature(s) reported. Complete results and background can be found in the subsequent sections of this report.

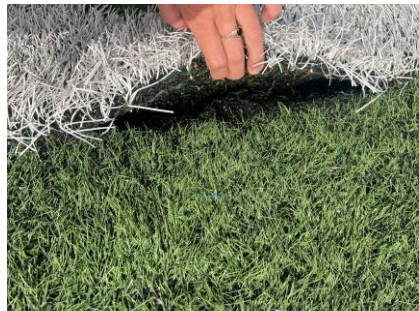
Item 8

Item No.	X	Y	Length, X (ft)	Width, Y (ft)	Deviation Type	Comments
1	I.3	5			FL- Loose Fibers	White fibers loose around entire field
2	E	3.1	0.5	0.5	SF – Seam failure	
3	F	3.1	1	0.5	SF – Seam failure	
4	G	3.1	2	0.5	SF – Seam failure	
5	H.1	3.1	2	0.5	SF – Seam failure	
6	G.6	3.1	2	0.5	SF – Seam failure	
7	H.6	3.1	2	0.5	SF – Seam failure	
8	H.6	3.2	1	0.5	SF – Seam failure	
9	I	3.2	1	0.5	SF – Seam failure	
10	J	3.2	1	0.5	SF – Seam failure	
11	J.2	3.2	1	0.5	SF – Seam failure	
12	L	4.5	2	0.5	FW - Worn Fibers (High wear)	Yellow fibers across entire field degrading faster than green and white
13	J.6	5	5	5	FW - Worn Fibers (High wear)	
14	I	6.7	2	0.5	SF – Seam failure	
15	H	6.7	0.5	0.5	SF – Seam failure	
16	G.1	6.7	0.5	0.5	SF – Seam failure	
17	F.7	6.7	0.5	0.5	SF – Seam failure	
18	G	5	3	0.5	FW - Worn Fibers (High wear)	
19	F	6.7	0.5	0.5	SF – Seam failure	
20	E	6.7	1	1	SF – Seam failure	
21	D.2	6.7	2	2	SF – Seam failure
